Manhole Inspection Summary

Manhole # S31II1002MH

Location Address: **WARRENTON RD**

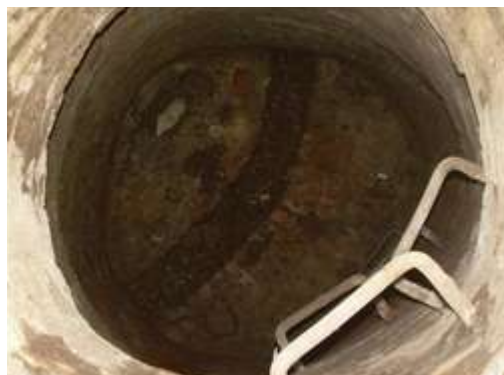
Top View

Condition: ☒ Sound ☐ Cracked ☐ Root Intrusion ☐ Deteriorated ☐ Leaks ☐ Debris

Condition: ☐ Sound ☐ Cracked ☐ Root Intrusion ☐ Deteriorated ☐ Leaks ☒ **Debris**

Bench and Channel debris.

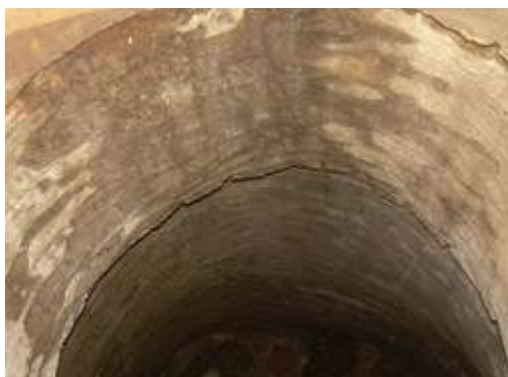
Defect

Infiltration: ☐ None ☒ **Joint** ☐ Cracks ☐ Mortar ☐ Roots ☒ **Wall**

Infiltration: ☐ None ☐ Joint ☐ Cracks ☒ **Mortar** ☐ Roots ☒ **Wall**

Adjustment and Corbel infiltration.

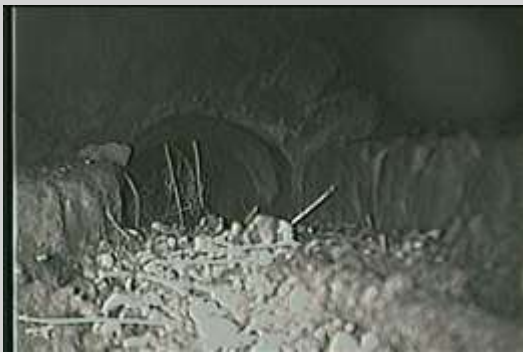
8 in. Circular Gravity Sewer Pipe Out @ 12 O'Clock

Deposits: ☐ None ☒ **Mud** ☐ Sludge ☒ **Debris** ☐ Grease

Silt Depth: **3** (in.) Deposits Extent: **Medium**

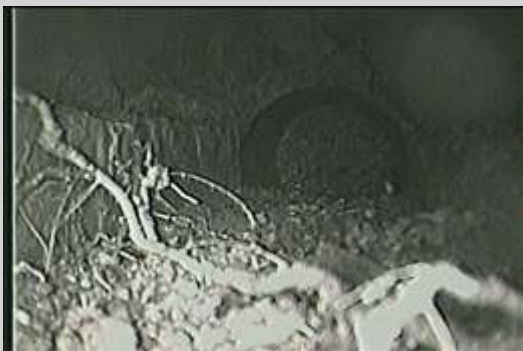
Pipe In @ 7 O'Clock

Deposits: ☐ None ☒ **Mud** ☐ Sludge ☒ **Debris** ☐ Grease

Silt Depth: **2** (in.) Deposits Extent: **Medium**

Infiltration: **None** Pipe Seal Cond: **Cracked**
